ITEMS IN THE VICINITY OF PORT MAIN DIESEL ENGINE

All Images Taken During Milner Survey, Taken June 6, 2022

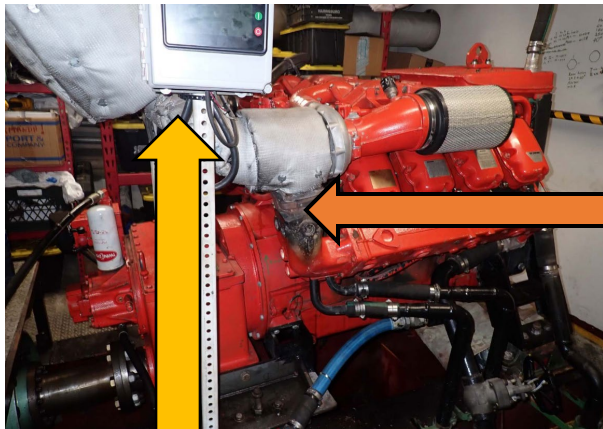
Turbocharger That Was To Be Replaced

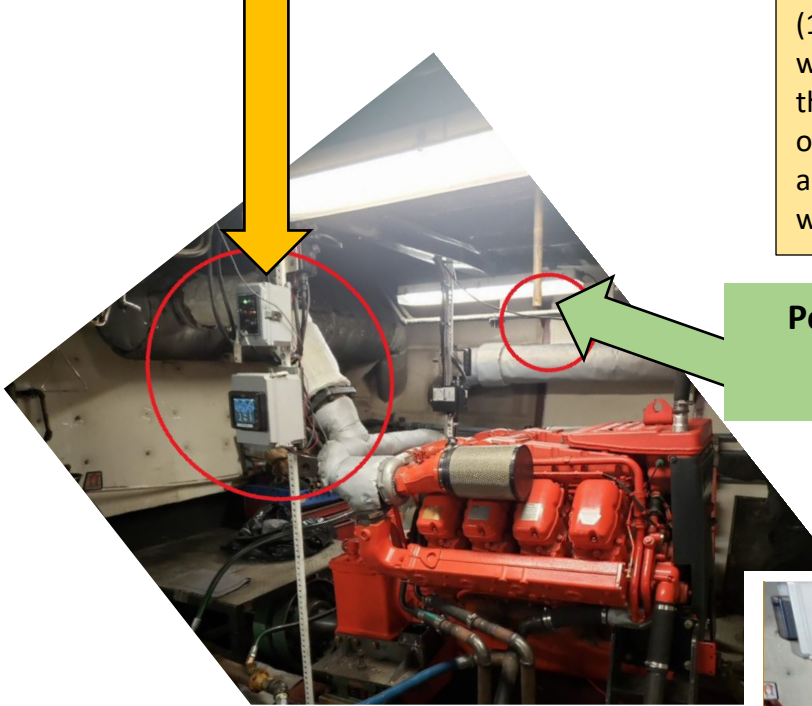
**Engine Control Module Equipment
(Port Engine)**

Post Fire Parted And Damaged Hydraulic Pipe

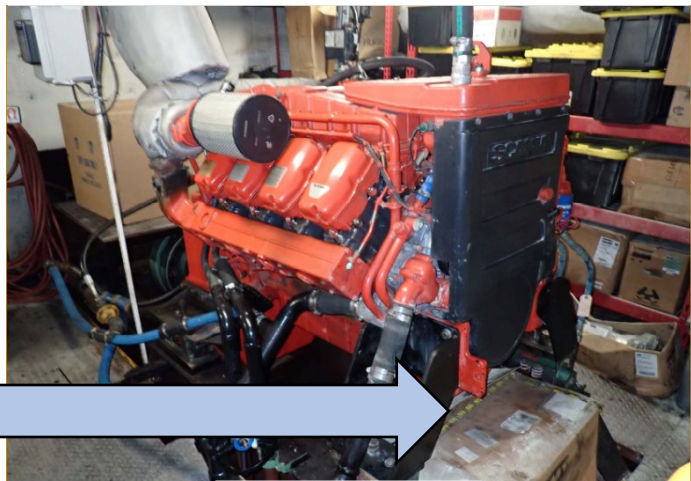
Large Carboard Box Stowed Immediately Below Front Of Port Engine
