# National Transportation Safety Board

DCA22FM022

## MATERIALS LABORATORY

Factual Report 22-080

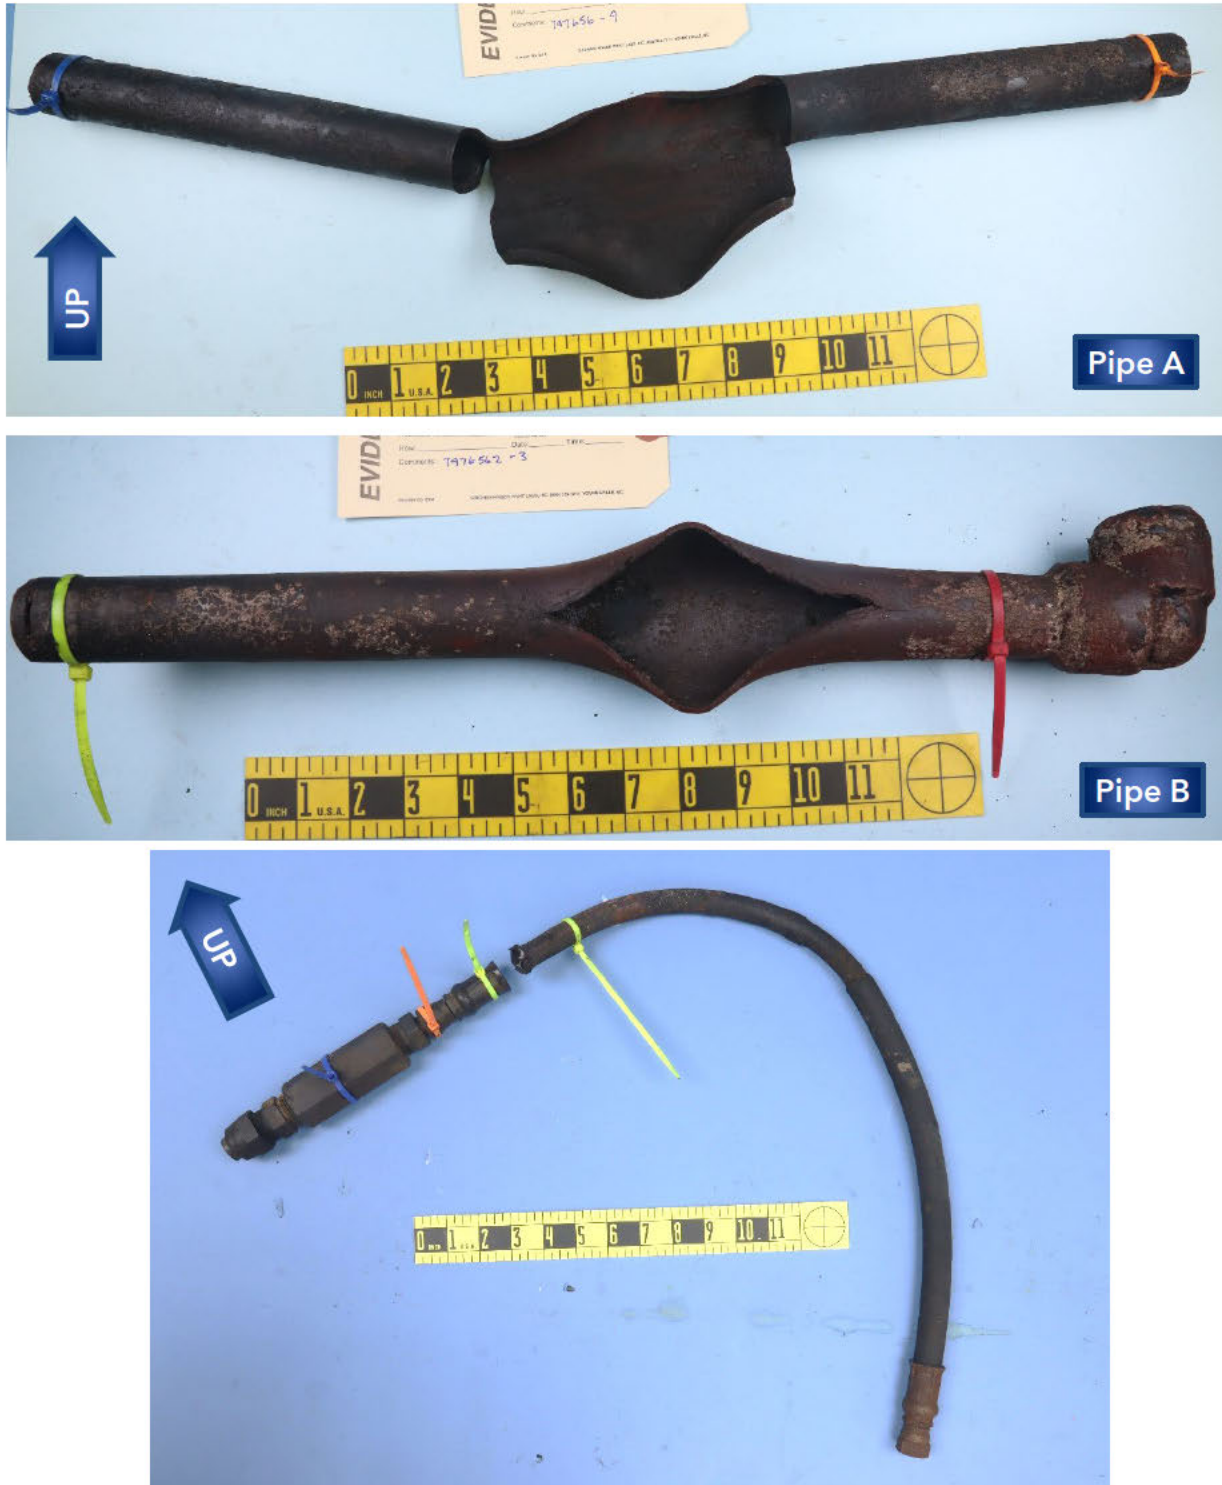
Overall views of the submitted components are shown as received in figure 1. One pipe piece (upper image in figure 1 shown labeled pipe A for this report) was cut from a location at the outboard side of the port engine. The other pipe piece (middle image in figure 1 shown labeled pipe B for this report) was cut from pipe located in the hydraulic pump space. The hydraulic relief valve hose and fittings were also collected from the hydraulic pump space. All components were reportedly associated with the hydraulic steering system. The fittings at the upper end of the hose were disassembled from the steering hydraulic pump reservoir, and the hydraulic hose was disassembled from the relief valve.

All components were tinted dark and were heavily oxidized consistent with exposure to heat and fire. On the hydraulic hose, heat damage was more substantial at the upper end of the hose where the liner and external sheath were both missing, leaving only the braided reinforcement. On the lower half of the hose, the external sheath remained in place. The condition of the internal liner at the lower end of the hose was not determined. The reinforcement braid consisted of two layers of reinforcement, consistent with the system engineering drawing specification.

The two pipes were fractured longitudinally at the upper side of each pipe. On pipe A, the longitudinal fracture transitioned to circumferential fractures that extended around most of the pipe circumference at each end of the longitudinal fracture. The hydraulic hose had separated from the crimped sleeve for the hose end fitting at the upper end of the hose.

**Figure 1.** Overall views of the hydraulic pipe located at the outboard side of the port engine (upper image), upper side of the hydraulic pipe from the hydraulic pump space (middle image), and hydraulic relief valve hose and fittings (lower image).

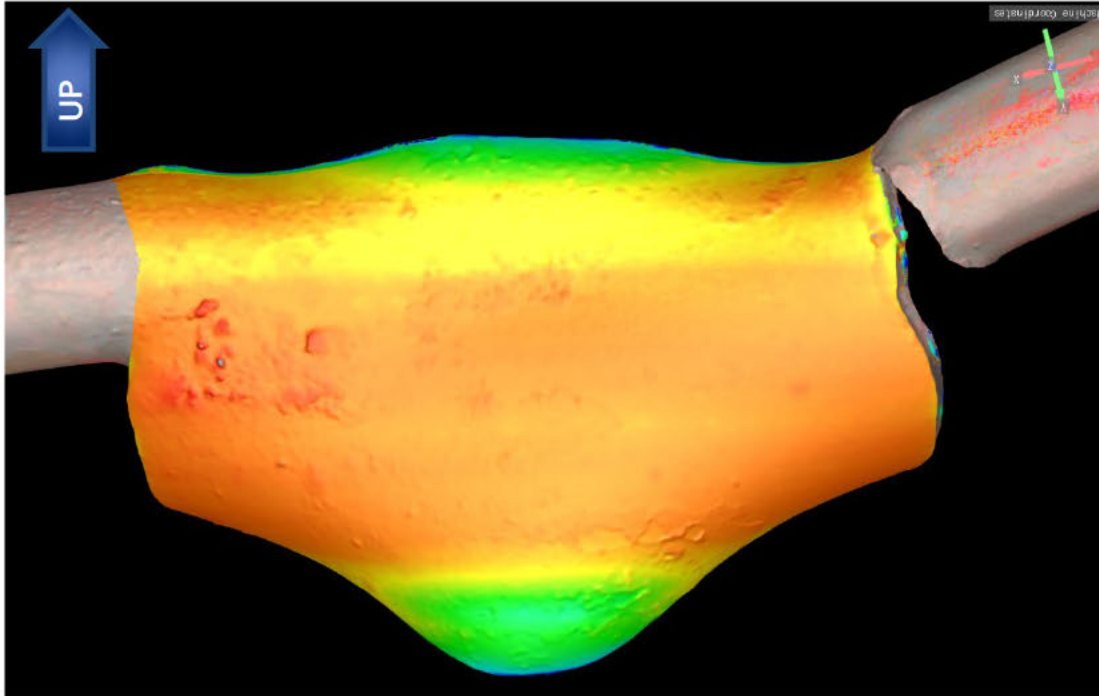
The section of pipe A between the circumferential fractures was deformed from a cylindrical shape to a shape resembling a wavy plate with curled edges. The fractured and deformed section was placed into a Keyence VL 500 series 3D scanner, and a thickness contour map showing thickness variations for the section between the circumferential fractures was produced as shown in figure 2. The thickness contours showed the wall thickness was relatively thinner in a circular area (appearing yellow, green and blue in figure 2) that would have been at the upper side of the pipe before fracture. The thinner area was also associated with an outward bulge in the wall.

**Figure 2.** Thickness contour map image of pipe A obtained using a Keyence VL 500 series 3D scanner showing the external side of the pipe fracture (opposite view from figure 1). Blue, green, yellow, orange, and red colors indicate thickness variation from thinner to thicker.

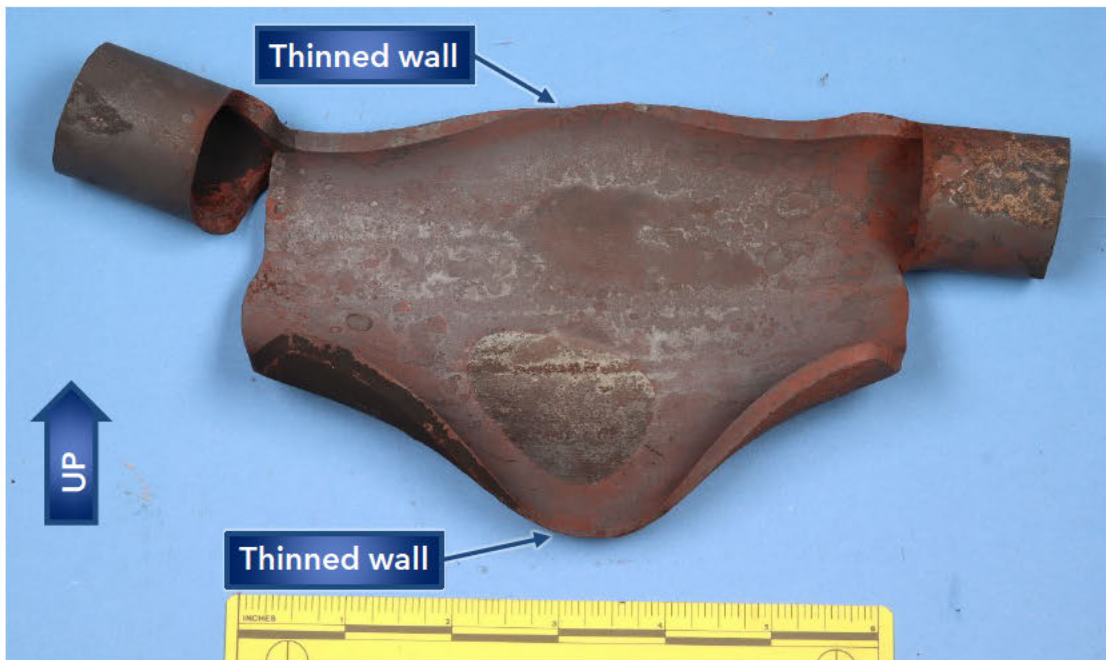
Views of the pipe A fracture after soaking in Evapo-Rust are shown in figures 3 and 4. The longitudinal fracture occurred on a slant plane consistent with ductile overstress fracture. At the middle of the fracture, the wall showed thinning deformation and outward deformation, consistent with substantial local plastic deformation before fracture.

**Figure 3.** Closer view of the pipe A fracture after sectioning and partial oxide removal. Areas of reduced wall thickness at the fracture location are indicated.

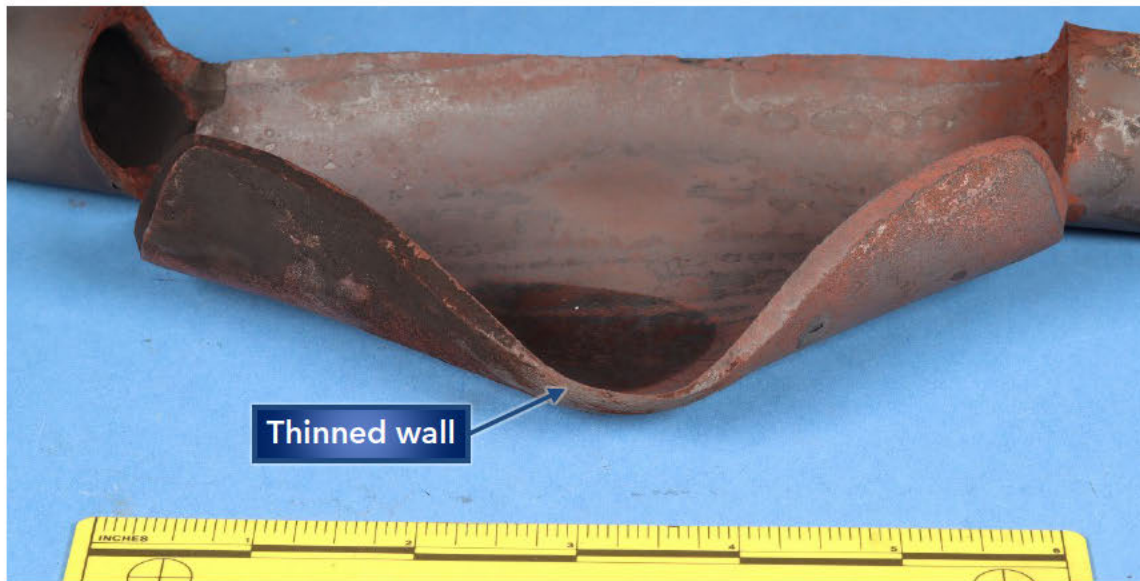
**Figure 4.** View from the lower side of pipe A showing wall thinning at the center of the bulge in the fracture location.

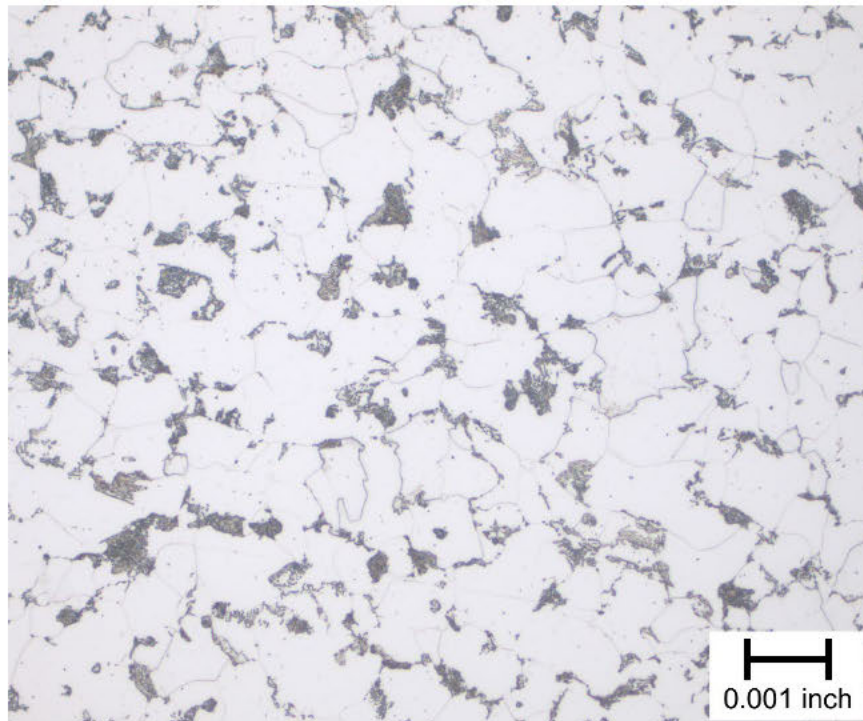
One of the pieces cut from pipe A before starting the oxide removal procedure was further sectioned to prepare a sample for metallographic examination of the transverse cross-section. An approximately ¼-inch ring section from pipe A was submerged in Alconox and warm water and cleaned using an ultrasonic cleaner before mounting in a metallurgical mount using a hot press. The mounted sample was then polished and etched with 2% nital<sup>4</sup> to reveal the microstructure as shown in figure 5. The microstructure consisted of mostly ferrite with partially spheroidized pearlite, consistent with a low-carbon steel exposed to high heat.

**Figure 5.** Typical microstructure for pipe A. White areas are ferrite, and darker areas are partially spheroidized pearlite. (Etched with 2% nital.)

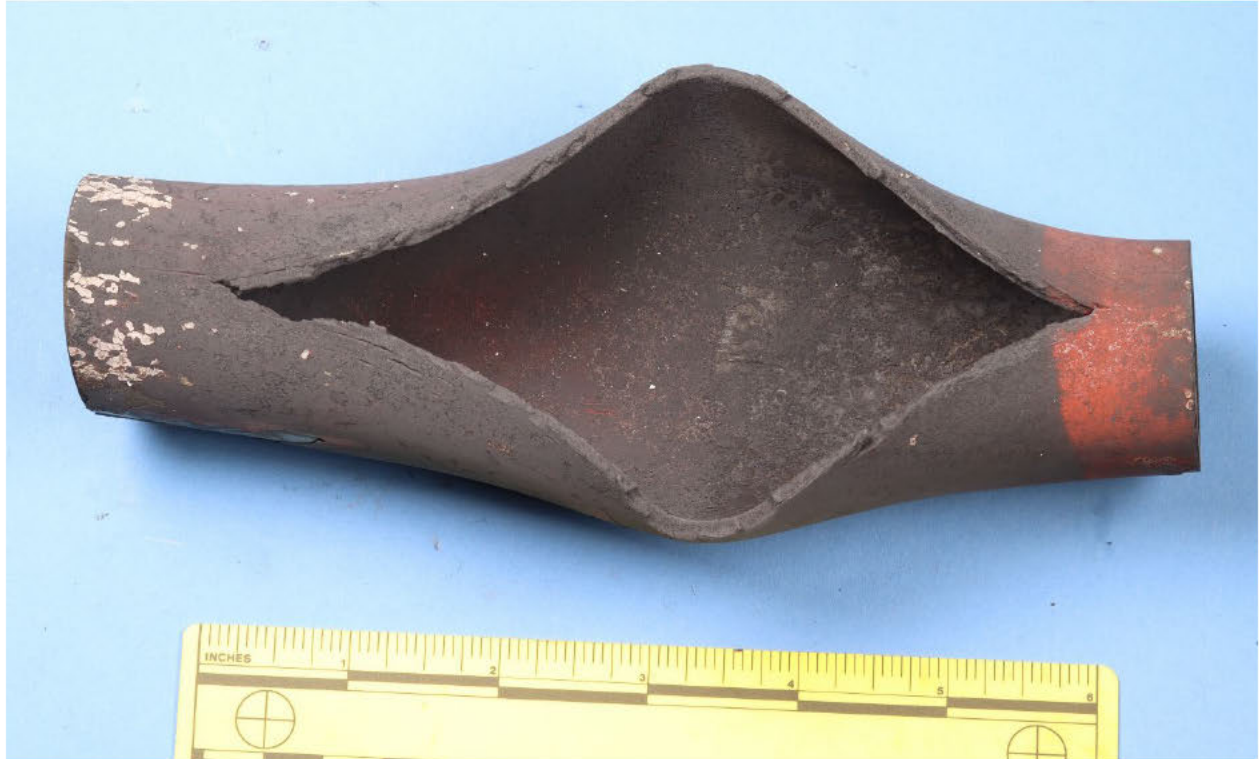
Next, pipe B was examined after the 24-hour soak in Evapo-Rust. The longitudinal fracture occurred mostly in planes perpendicular to the pipe surfaces. Although general macroscopic features were visible, relatively thick oxides remained covering all surfaces including the fracture surfaces. To assist in removing more oxides, pipe piece B submerged in a beaker of Evapo-Rust, and the beaker was placed in an ultrasonic cleaner for 1 hour followed by brushing to remove loose material. Views of the pipe B piece after deoxidation in the ultrasonic cleaner are shown in figures 6 and 7. The middle portion of the fracture occurred on multiple planes in longitudinal segments linked by short circumferential fractures joining the longitudinal segments to form a step-like pattern to the fracture. Many of the step edges were curled inward consistent with the final separation at the step edges as the pipe fracture opened. Multiple longitudinal crack-like pits were also observed adjacent to the fracture surface such as those indicated with unlabeled arrows in figure 7. The longitudinal fracture planes appeared to coincide with the locations of the crack-like pits such as the one shown by the arrow at the right side of the image in figure 7.

**Figure 6.** Close view of the pipe B fracture after sectioning and partial deoxidation.

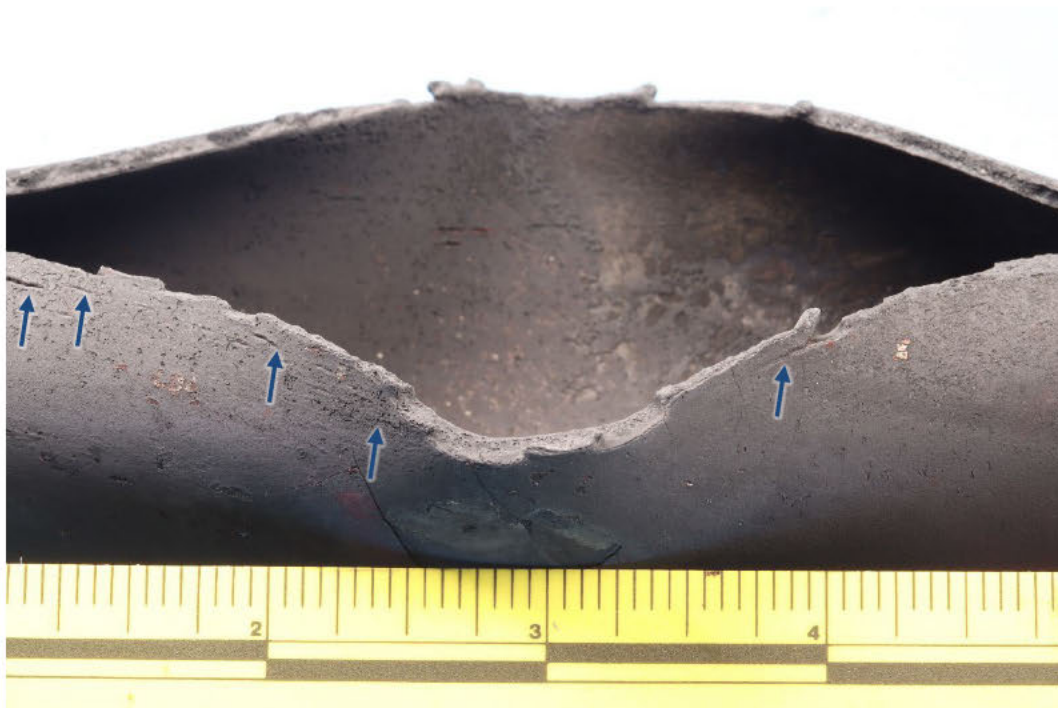
**Figure 7.** Oblique view of the pipe B fracture showing step features in the fracture plane corresponding to longitudinal crack-like pits (indicated with unlabeled arrows) on the exterior surface.

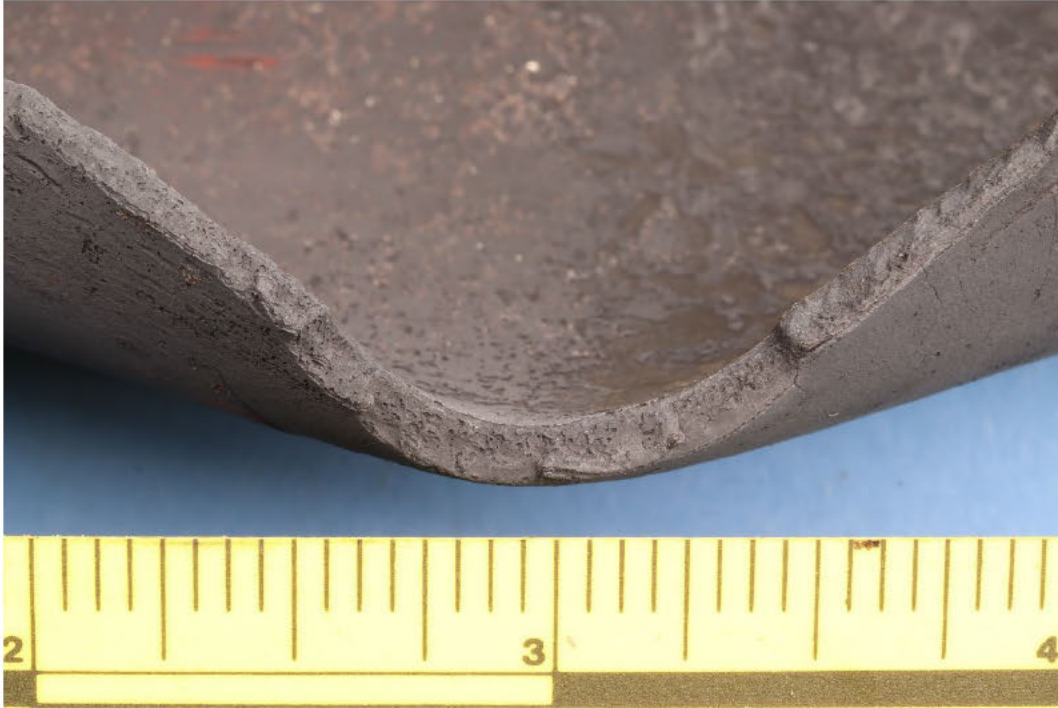
A view of the fracture surface for pipe B at the location of greatest opening displacement is shown in figure 8. The fracture surface had shallow pits in the oxidation layer likely from uneven removal of oxides during the ultrasonic removal stage, and fine fracture features remained obscured and likely obliterated by post-fracture oxidation. However, the overall pattern of fracture showed flat fractures on multiple planes with limited wall thinning associated with the fracture. At the step edges, there was more overlap of adjacent fracture planes at the outer surface, consistent with fracture initiation from the longitudinal crack-like pits on the exterior surface.

**Figure 8.** Fracture surface at the center of the longitudinal fracture in pipe B.

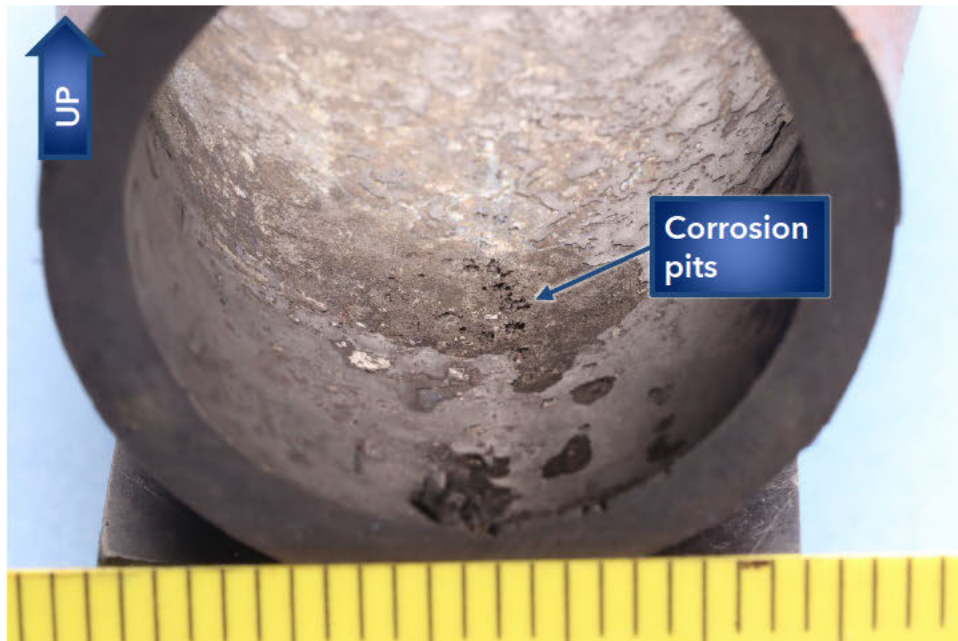
Corrosion pits were also observed on the interior surface on the lower side of the pipe after deoxidation in the ultrasonic cleaner. A view of some of the exposed pits is shown in figure 9. No cracks were observed associated with the pits on the lower side of the pipe.

**Figure 9.** Corrosion pits on the interior surface on the lower side of pipe B.

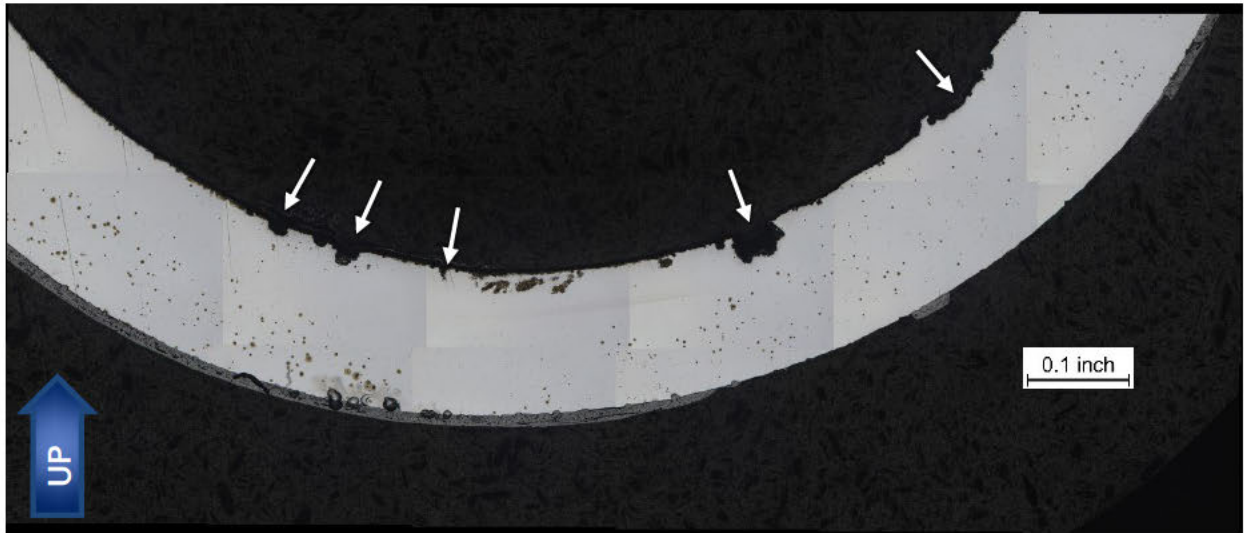
transverse cross-section. An approximately ¼ inch ring section from pipe B was submerged in Alconox and warm water and cleaned using an ultrasonic cleaner before mounting in a metallurgical mount using a hot press. The mounted sample was then polished and examined using a Zeiss AxioObserver inverted metallograph. A stitched montage of micrographs imaging the as-polished lower section of the pipe is shown in figure 10. Arrows point to corrosion pits on the inner surface of the pipe. No cracks were observed emanating from the pits.

**Figure 10.** Stitched montage of micrographs of the as-polished cross-section through pipe B. Arrows point to corrosion pits on the interior surface at the lower side of the pipe.

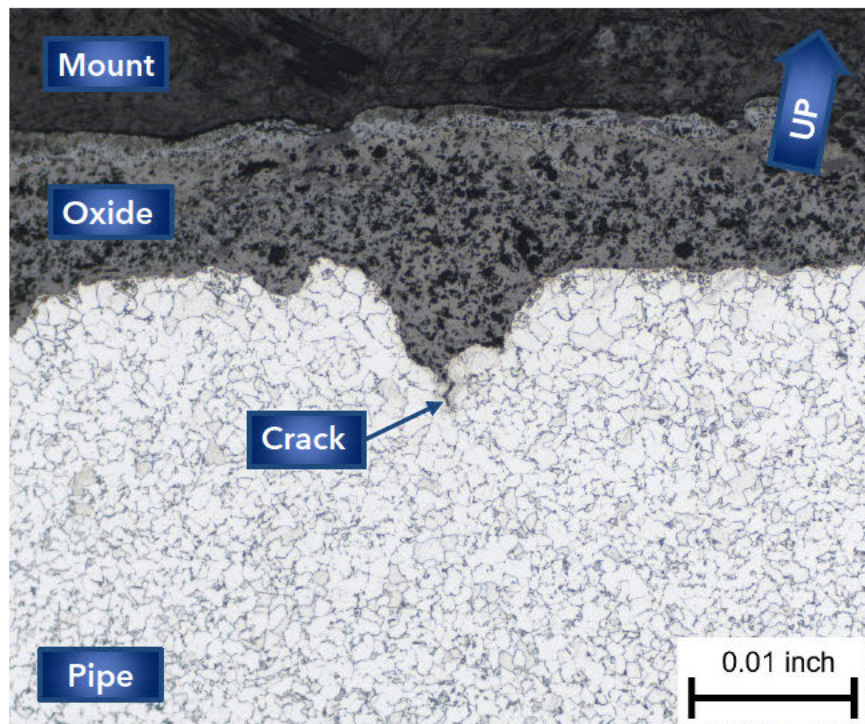
The polished cross-section of pipe B was then etched with 2% nital. The transverse cross-section intersected multiple longitudinal crack-like pits on the exterior surface on the upper side of the pipe. One of the larger of these crack-like pits is shown in figure 11 on the etched cross-section. A thick oxide layer covered the surface as shown, including the crack-like pit. The profile of the crack-like pit had a rounded tip like that of a pit. A crack extended from the lower end of the pit as indicated in figure 11.

**Figure 11.** Micrograph showing a crack extending from a crack-like pit in the exterior surface on the upper side of pipe B.

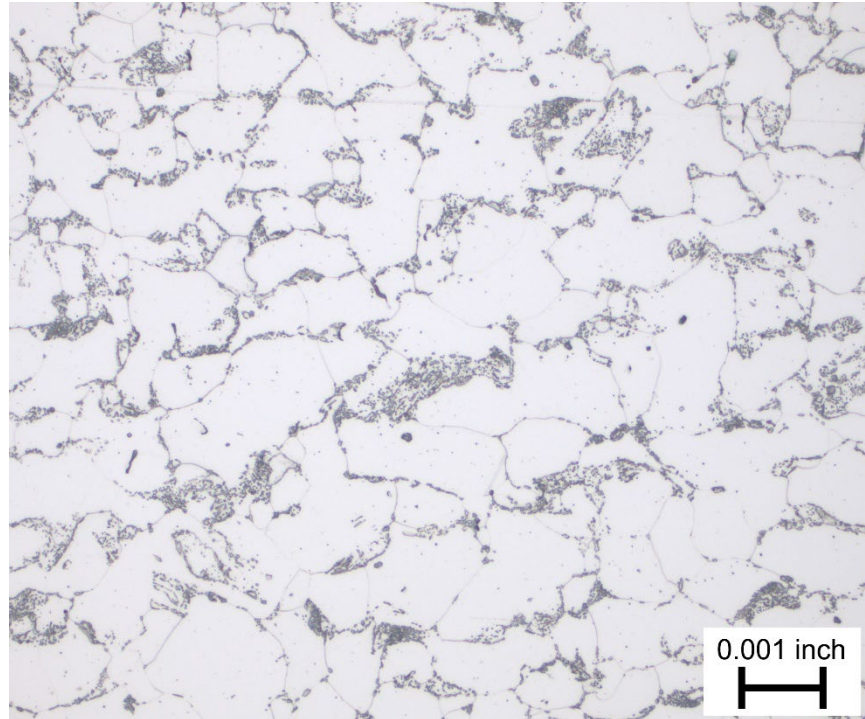
A micrograph of the etched sample showing typical microstructural features for pipe B is shown in figure 12. The microstructure consisted of mostly ferrite with mostly spheroidized pearlite, consistent with a low-carbon steel exposed to high heat.

**Figure 12.** Typical microstructure for pipe B. White areas are ferrite, and darker areas are pearlite that has been mostly spheroidized. (Etched with 2% nital.)

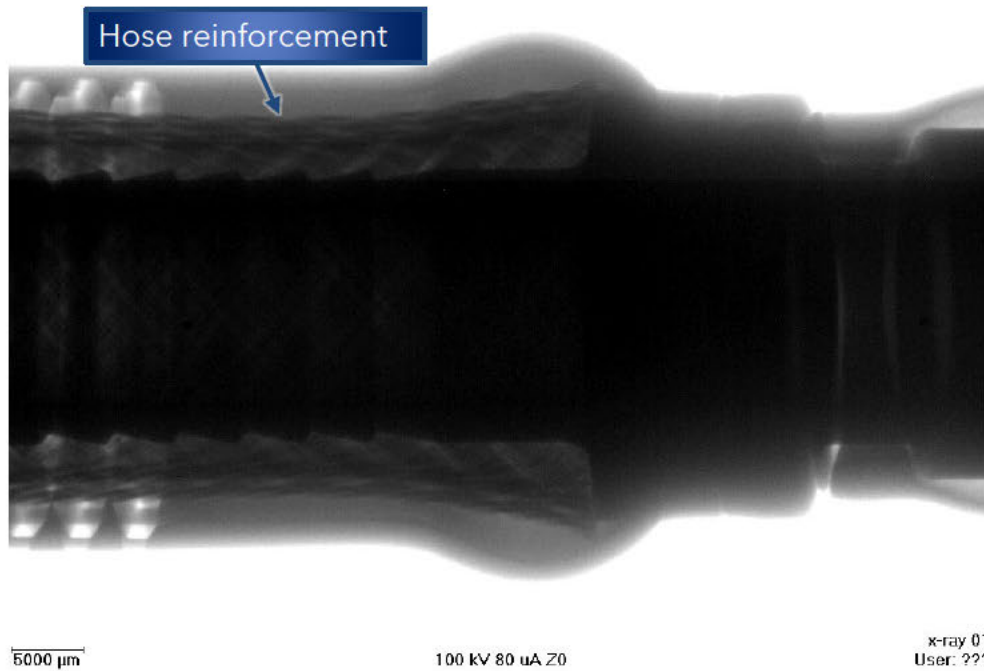
The fitting at the intact end of the hose was examined using radiographic (x-ray) imaging, and the resulting radiograph is shown in figure 14. The overall geometry of the of the braided hose reinforcement within the crimped sleeve had a slight outward flare within the last  $\frac{3}{4}$  inch from the tube end with no significant change in the last  $\frac{3}{8}$  inch. The fitting at the separated end was also examined using radiographic imaging as shown in figure 15. No braided hose reinforcement remnants were detected within the crimped sleeve.

**Figure 14.** Radiograph of the intact hose end within the crimped sleeve at the lower end of the hose.

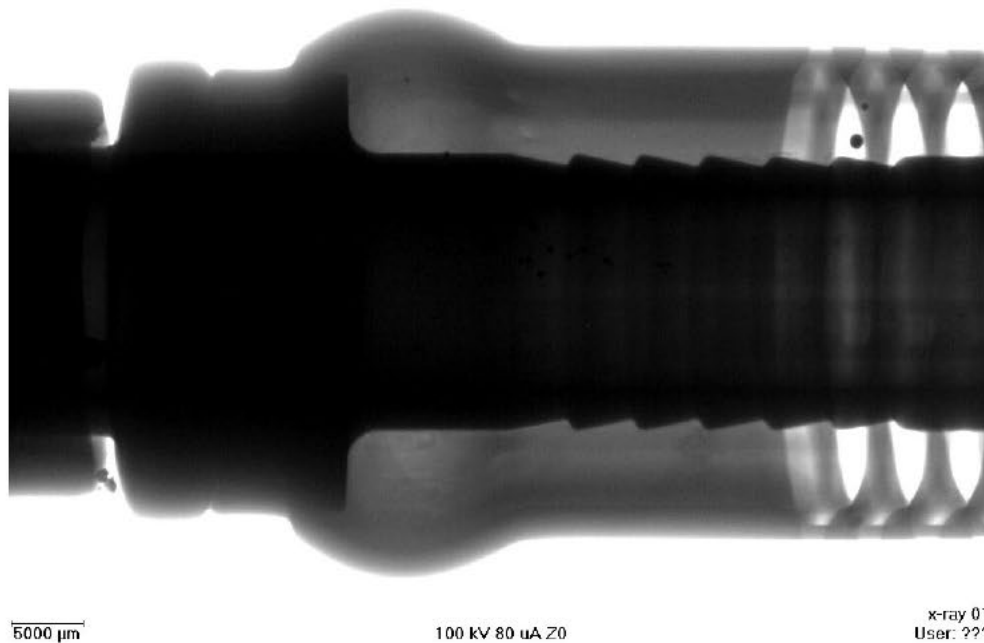
**Figure 15.** Radiograph of the crimped sleeve at the upper end of the hose.
