## **Marine Safety Information Bulletin**

Ninth CG District Commander U.S. Coast Guard Inspections and Investigations Branch 1240 E. Ninth St. Cleveland, OH 44199-2060 MSIB Number 001-18 Date: March 20, 2018 Contact: LT Jerry Federer Email: Jerrold.l.federer@uscg.mil

## IMPROPER REPAIR AND MAINTENANCE OF IMMERSION SUITS

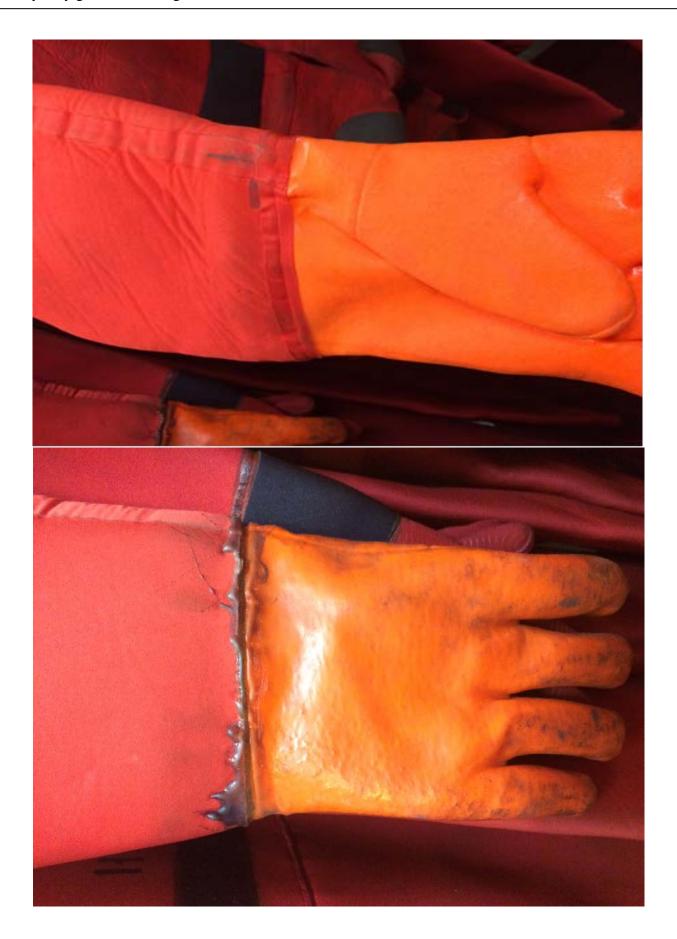
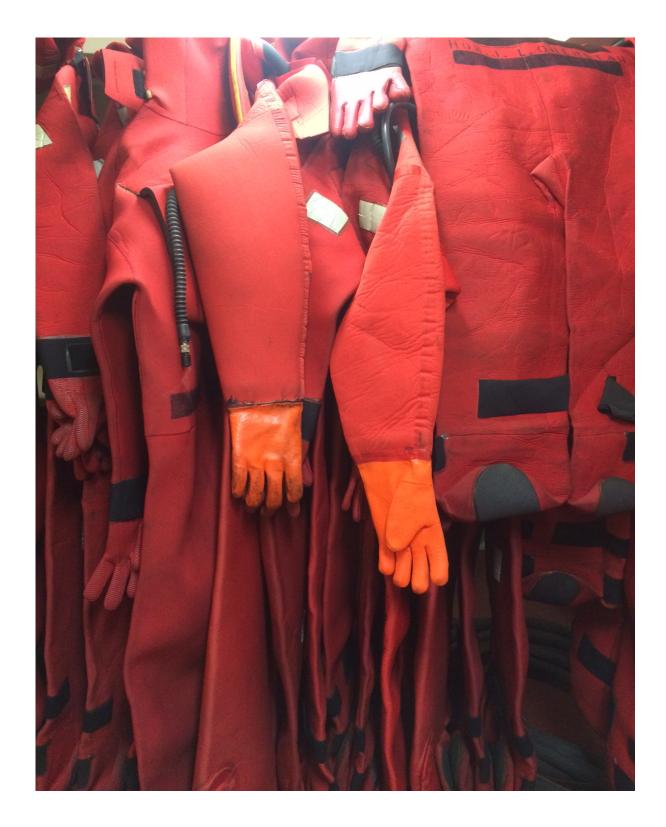
Not just any neoprene suit satisfies Coast Guard requirements for immersion or survival suits. On the aforementioned suits, the original neoprene gloves had been removed and replaced with rubber glove with an unapproved, uninsulated general industrial rubber glove (See Photos). At a glance, the repair appears to be an approved repair making the watertight seal between the gloves and the suit. However, after a closer inspection, it was discovered that the gloves were not Coast Guard approved, having no thermal insulation properties.

**Below:** The following pictures show that the original neoprene glove was removed and replaced with a heavy duty generic rubber glove.

Immersion Suits must be CG Approved and repairs must be made in accordance with manufactures specifications. Approved suits, gloves, boots, and hood are integral to the entire suit that must pass rigorous testing procedures by Coast Guard-accepted, independent laboratory. The neoprene material itself provides buoyancy, and the bladder at the back is designed to turn an unconscious person face-up immediately. Reflective tape patches are installed by the manufacturer according to Coast Guard requirements that specify the number of patches and their positions. The locations of these reflective patches should not be changed. Per NVIC 01-08, the seams and closures of immersion suits experience deterioration over time. However, even under ideal conditions, the materials and adhesives used have a finite service life, and will inevitably experience reductions in strength, buoyancy, and/or water-tightness with age. NVIC 01-08 can be located at: http://www.dco.uscg.mil/Our-Organization/NVIC/Year/2000/.

**ACTION:** Spring Break-out provides an opportunity for close inspection of a vessel's Immersion Suits; Owners and Operators should pay particular attention to immersion suits, looking for improper repairs and serviceability. Ensure owner/operators are having immersion suits repaired to the manufactures specification. Owner/Operators should ask the approved servicing location to evaluate whether an old suit is still serviceable and safe. In additions to the proper repairs, ensure immersion suits are being correctly stowed being readily accessible. The suit must fit. Have the mariner try it on again this spring. The suit must have working, lubricated zippers and Coast Guard-approved lights (strobe lights are best). The oral inflation tubing and the flotation bladder must be free of leaks. The material also must be free of rips and tears. Neoprene fabric degrades over time and can lose its original buoyancy and fabric integrity.
