# Marine Safety Information Bulletin

MSIB Number: 001-16  
Date: March 21, 2016  
Contact: LT Michael J. Collet  
Phone: (216) 902-6051  
Email: Michael.J.Collet@uscg.mil

## Electrical Systems

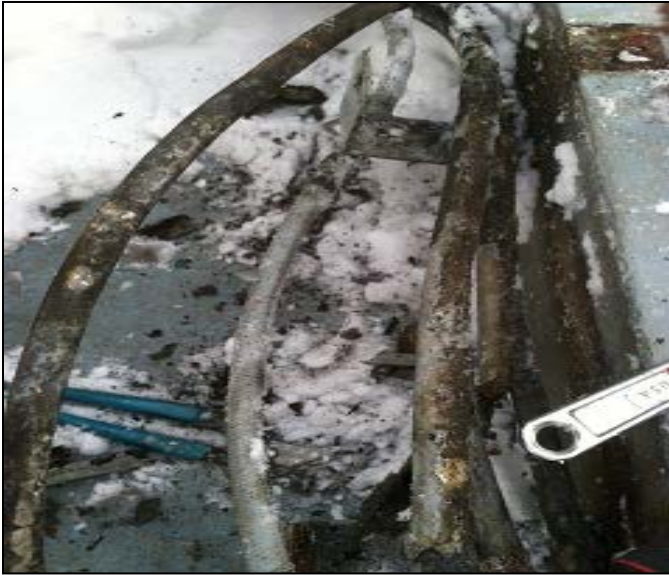
**Below:** (Left) Wiring exposed to weather on main decks and super structures are susceptible to deterioration. Wires were heavily deteriorated on side that was in contact with steel framing. (Right) Deterioration was not noticeable until wires were pulled away from deck.

- *Deteriorated wiring:* wiring exposed to water can become deteriorated over time compromising the integrity of the sheathing and insulator. This can cause a circuit short or fault and in some cases result in a component failure and/or fire.

**RESPONSIBILITY:** Ultimately, the master is responsible for the vessel's safety. Routine inspections of the vessel's electrical systems should be conducted. It should not be assumed that all discrepancies are identified during fit-out exams. Some items require attention and troubleshooting beyond the scope of an annual exam. Wiring and cable trays exposed to the weather or water pose a greater risk. Any issues found should be corrected immediately. Servicing and maintenance of electrical systems should be conducted by appropriately trained personnel and in accordance with applicable regulations and standards.

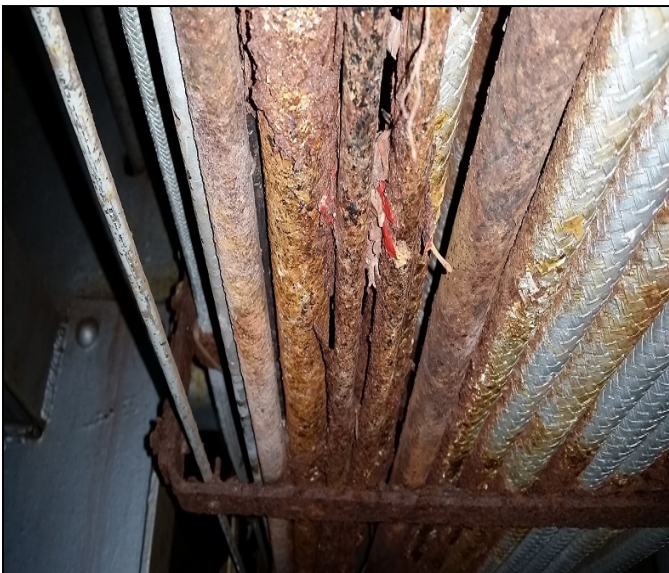
**Below:** (Left) Watertight integrity between SPAR deck and upper walking tunnel compromised. Wiring was being exposed to water and subsequently deteriorating over time. Wiring group from distribution panel passes through sheet metal penetration to overhead wire way. (Right) Chafing can cause excessive wear to sheathing and insulator and ultimately failure of the wire.

- *Compromised watertight integrity:* When wiring that penetrates a watertight bulkhead is replaced the penetration must be made watertight. If it is not properly address the watertight integrity and fire boundary of the space becomes compromised.
